Erickson's
Flooring & Supply Company

Warranty Claims
&
Self Inspection Program

2007

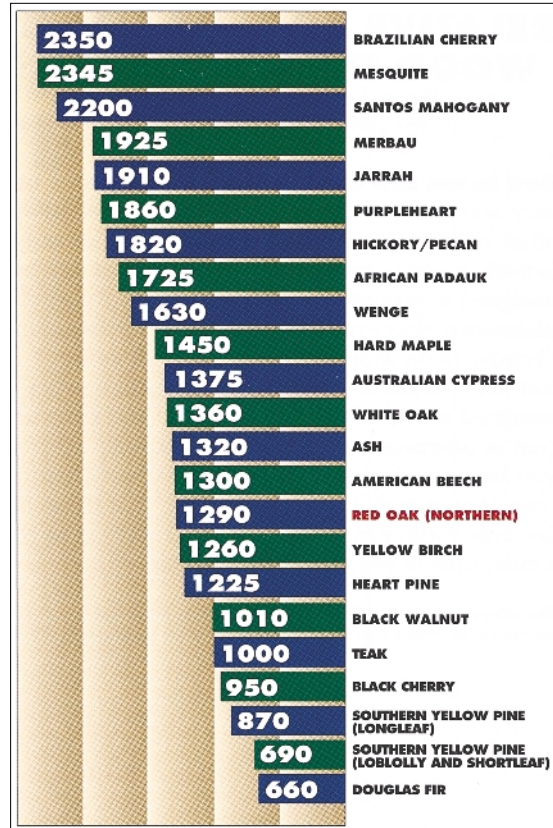
RELATIVE HARDNESS OF SELECTED WOOD FLOORING SPECIES

(Ranked by Janka hardness rating)

The Janka (or side) hardness test measures the force required to embed a .444-inch steel ball to half its diameter in wood. It is one of the best measures of the ability of a wood species to withstand denting and wear. By the same token, it is also a good indicator of how hard or easy a species is to saw or nail. Northern red oak, for example, has a Janka hardness rating of 1290. Brazilian cherry, with a rating of 2350, is nearly twice as hard. If you're accustomed to working with red oak and decide to tackle a job with Brazilian cherry, you can expect it to be much harder to cut and nail.

- Source: Hardness ratings for most species taken from Wood Handbook: Wood as an Engineering Material (Agriculture Handbook 72, Forest Products Laboratory, Forest Service, U.S. Department of Agriculture; revised 1987), except for Australian cypress, wenge, African padauk, merbau and Santos mahogany, which were provided by International Hardwood Flooring; heart pine by Mountain Lumber, and mesquite by Mesquite Products of Texas.
- Douglas fir rating is an average of ratings for Coast, Interior West and Interior North species.

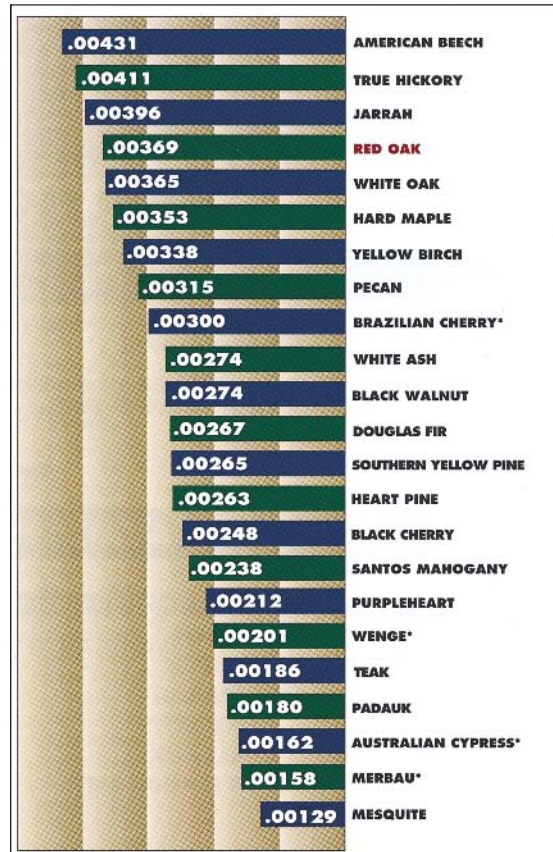
RELATIVE STABILITY OF SELECTED WOOD FLOORING SPECIES

(Ranked by dimensional change coefficient)

The chart is best used for comparison.

* Although some tropical woods such as Australian cypress, Brazilian cherry, merbau and wenge appear in this chart to have excellent moisture stability compared to domestic oak, actual installations of many of these woods have demonstrated significant movement in use. To avoid problems later, extra care should be taken to inform potential users of these tendencies prior to purchase.

• Source: Stability ratings taken from Wood Handbook: Wood as an Engineering Material (Agriculture Handbook 72, Forest Products Laboratory, Forest Service, U.S. Department of Agriculture; revised 1987).
